## Historic Structure Report for St. Anne's Church

# Historic Structure Report for St. Anne's Church

National Park Service  
Historic Preservation Fund Project  
#23-11-NA-2314  
July 2013

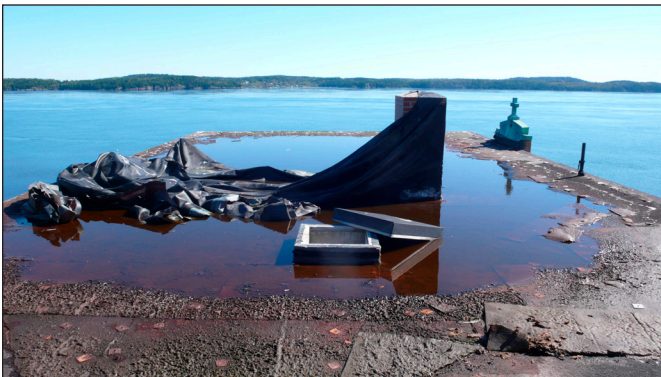
The steel structure appears to be intact, with moderate rusting in some locations. However, the flat, concrete roof at the Convent previously used a built-up membrane roofing system consisting of bitumen over a 3/4" felt, or perlite insulating board. More recently, a (poorly applied) rubber EPDM (Ethylene Propylene Diene Monomer Rubber) roof system was installed which has failed completely, having unattached from the roof due to high winds and negative pressure on the flat roof plane. This failed EPDM roof now sits

useless, as a pile on the roof, with severe ponding on the unprotected, pervious concrete roof and is largely responsible for severe moisture infiltration in the Convent building. The resulting failure of the building envelop has caused interior and exterior material failure. Interior plaster, paint and floor failures are attributable to moisture infiltration from the failed roof membrane. This moisture has migrated through the interior finish as well as from the roof perimeter and into the exterior brick wythes.

*View of the Convent Roof, June 2013, showing the former EPDM roof membrane torn off by wind, with severe ponding over the porous concrete roof. This roof has no protection from water infiltration and is leaking this water into the convent building.*

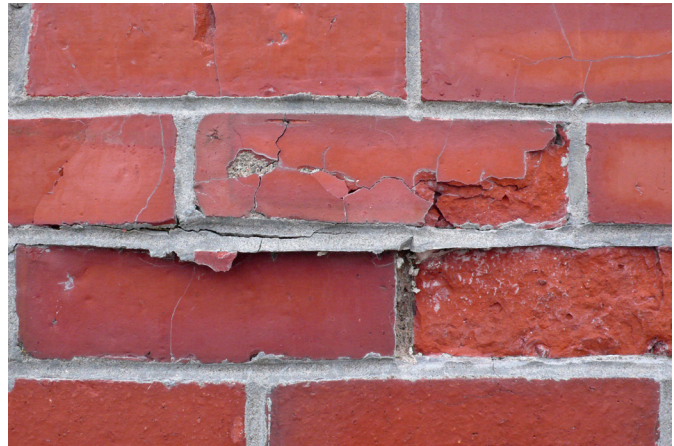
- Freezing and thawing cycle has caused fracturing of brick, as evidenced on the visible exterior elevations. Some brick has up to an inch of its face missing. Other bricks have vertical cracks suggesting water

voiding their integrity. Brick elevations throughout these buildings have been selectively repointed in the past. The mortar appears to be inappropriate in type and density, being harder than desired.

*An example of severe brick face spalling caused by improper re-pointing with a mortar that is too hard for the historic brick, causing moisture to move through the brick (instead of the mortar.) As the moisture in the brick freezes it causes the brick to disintegrate.*

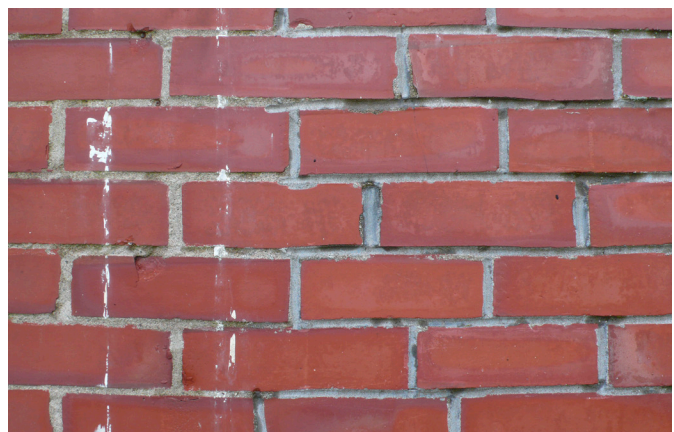
- Large sections of the masonry exterior have been rebuilt at varying levels of craftsmanship, mostly poor, using bricks of dissimilar color, texture and dimension. There is a mix of older "water-struck" bricks and more modern machine manufactured brick. Additionally, the characteristics of the mortar and re-pointing vary around the building exterior, ranging from the historic mortar, with its softer density and larger aggregate to the newer mortar, with its harder density, finer aggregate, and higher Portland cement ratio. The latter of which has contributed to widespread brick-face spalling. A condition which will require complete replacement of the outer wythe (layer) of brick.

*Photo showing a typical example of poorly executed brick replacement. On the left, older water-struck bricks and historic mortar. On the right, newer, machine made bricks of a different size with a different mortar composition.*

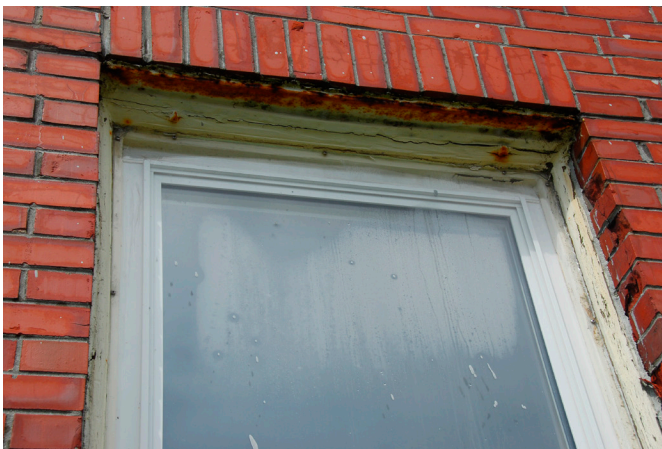
- Steel lintels over windows and doors are severely deteriorated through rust. A direct result of the water infiltration through the unprotected convent roof. With the exception of the stained glass windows, the majority of the original windows have been replaced with poor quality, failing vinyl windows. Lintel failure has allowed moisture infiltration and in some cases brick failure.

*Severely deteriorated steel lintel over cheap, vinyl replacement window in the Convent. This situation is typical of all the vinyl replacement windows on this part of the building.*

- » Replace all vinyl replacement windows with clad wood replacement windows, as noted elsewhere in report
- » Repair, replace all lintels to provide adequate bearing on brick units and maintain dimensional depth to suitably carry loads above

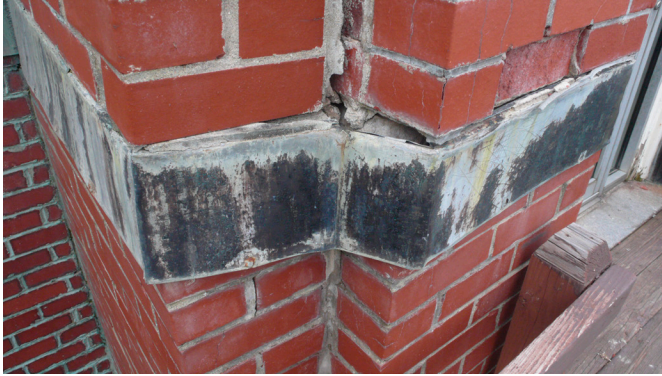
*Example of the Copper/Lead-Coated flashing which is typical to the building. It is used to cover the precast concrete sills, blocks, caps, parapets and trim ornaments. Here it is badly deteriorated and buckling due to pilaster failure on the bell tower.*

» Restore/replace existing copper/lead coated flashing as elsewhere . Proper mastic and mechanical fastening as required to create impermeable seal and architectural integrity.

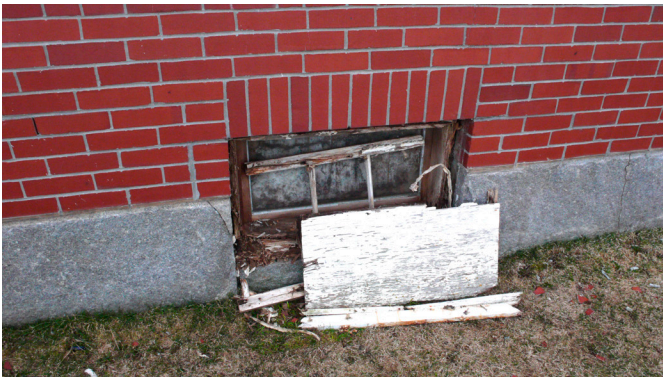
*All of the basement windows are covered and/or rotted. Replacing them with operable and secure units will provide both light and ventilation to the basement.*

- » All lintels above windows and doors should be repaired, resurfaced or replaced as necessary.
- » All basement windows should be returned to functionality at a minimum to provide daylight to the dark basement. Consideration should be made to choosing operable versus fixed units. Again, they should be durable and maintenance free.

- » Galvanized window wells should be installed at each location to mitigate moisture migration into the Basement
- » Repair/ Replace existing copper/lead coated flashings at coping and covering cast concrete elements. Caulk and seal with suitable sealant and mechanically fasten at appropriate locations so as to preserve weather tight coverage. Fastenings shall be as least visible as possible.
- » At roof level, restore cladding on East elevation of gable end of Church. Proper flashing and counter flashing should be installed to prevent leaking from Convent roof into adjacent Church. EPDM membrane must be properly terminated at this intersection of roof and wall.

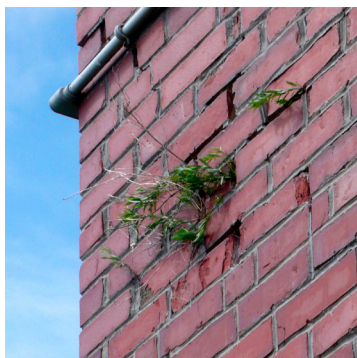
*Grass growing in the joints on the east side of the building.*

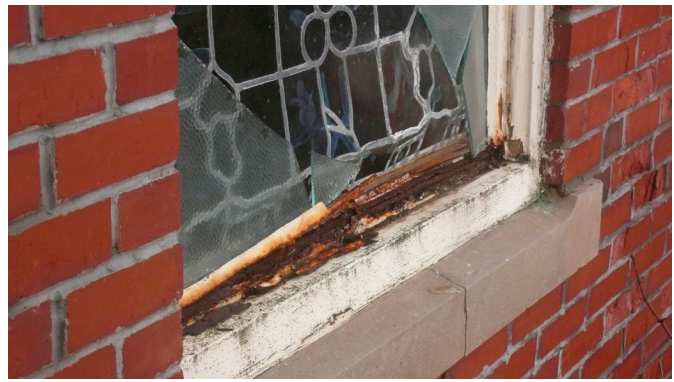
*Severely rusted metal frame on one of the stained glass windows causing buckling lead and broken protective outer glass.*

» Stained glass, here as in all other cases should be restored (glass, metal frames and wooden sash) as necessary. Existing (Unvented) Plexiglas sheets should be removed and replaced with a (glass or Plexiglas) system that provides passive ventilation to the exterior of the stained glass window. This will minimize future deformation and failure of the irreplaceable stained glass  
 » Stained glass window at Choir Loft should be inspected and repaired as necessary (glass and frame.)

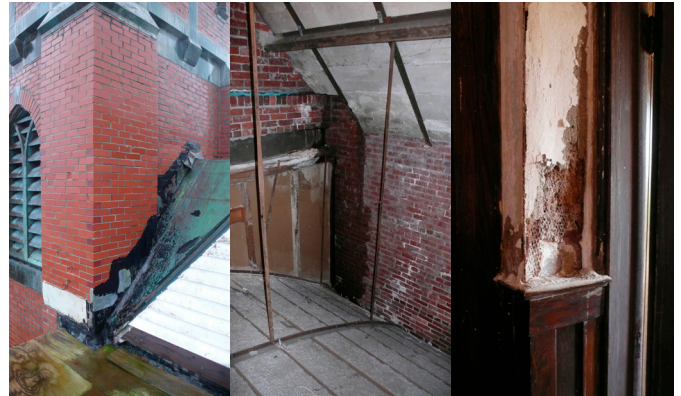
*Roof leaks at the tower/church connection (left) run down the inside of the tower/church wall (middle) causing deterioration of the plaster near the entry from the altar to the tower (right.)*

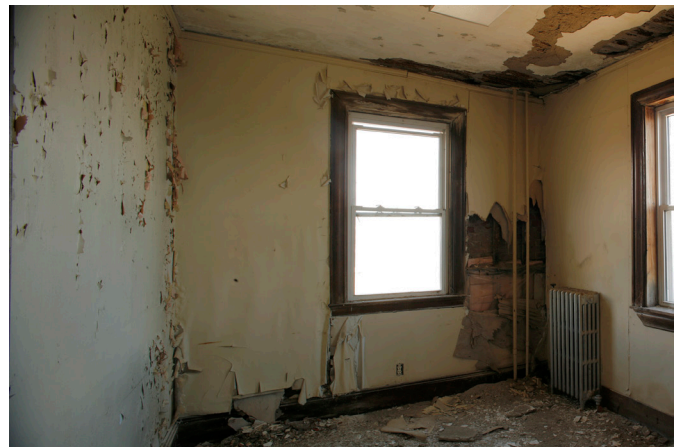
*1st Floor of the convent, typical conditions. Water leaking down from the roof saturates the walls causing the lathe and plaster to rot and rust. Ceilings and floors are saturated with water, growing mold and other fungi. Cheap vinyl replacement windows are failing, leaking air and holding moisture, quickening the deterioration of the window frames.*

- » Major plaster repair required on wall walls and ceilings. New plaster lath may be required in some locations due to rust and deterioration of original metal lath. Generally, repairs should be made with plaster unless deterioration is widespread and substrate is not usable. In that case only, drywall may be used. Moisture resistant products should be used in Pantry and Bath.

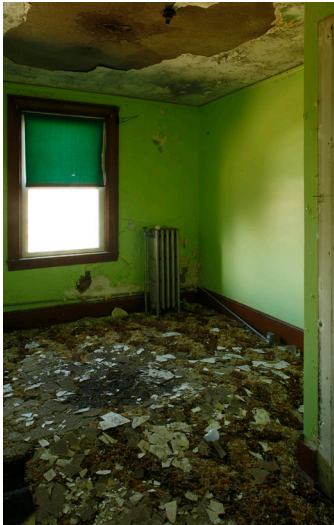
*2nd floor of the convent active leak in the roof is causing the wood floor to buckle severely.*

- » Remove, repair, and replace wood flooring. Consult Architect as to appropriate materials and methods regarding final treatment (sand/refinish vs. replace.)

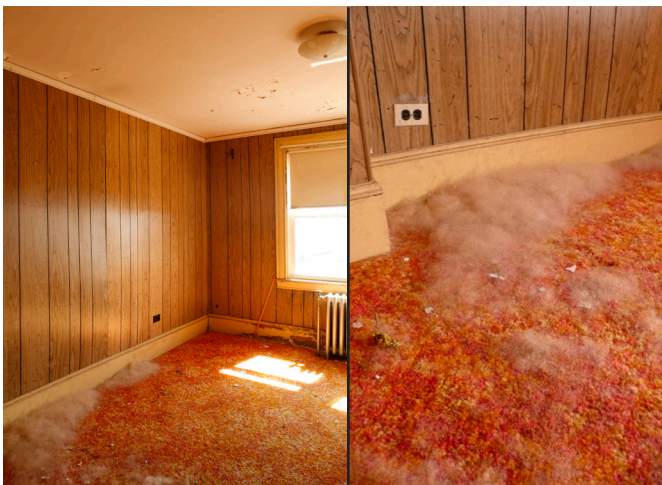
- » Mold shall be abated in all areas of project. Particular note is made of existing mold and moisture conditions.

*Mold growth on the second floor of the convent (Living Room, Southwest corner), one of several varieties thriving in the convent.*

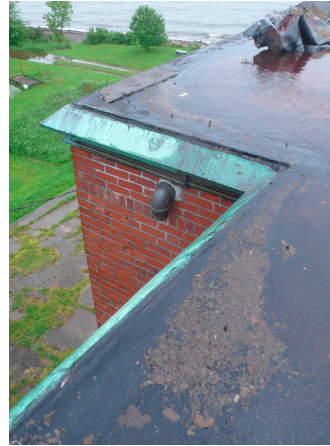
*Cornice detail, roof of the convent. Lead-coated copper trim and bituminous roofing.*

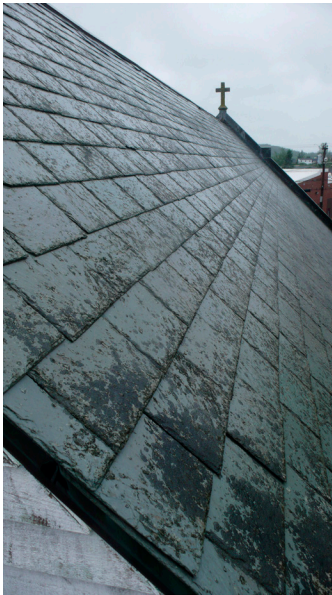
- » Slate is in good condition. In several areas, new slate tiles have been installed. While the color difference is noticeable, the dimension and stability are acceptable. There is no evidence of roof failure in the Church itself. At transition areas between the Church and Convent buildings, severe, constant, moisture infiltration exists, as evidenced by active leaks and material deterioration inside the area of transition and throughout the Convent.

» At some point in the next few years it can be expected that the membrane beneath the slate will have deteriorated and will require the removal and re-installation of the slate roof. There is no current issue with leaks within the Chapel.

*The slate roof of the church remains in fair condition. Photo of the North side. With mild lichen growth.*

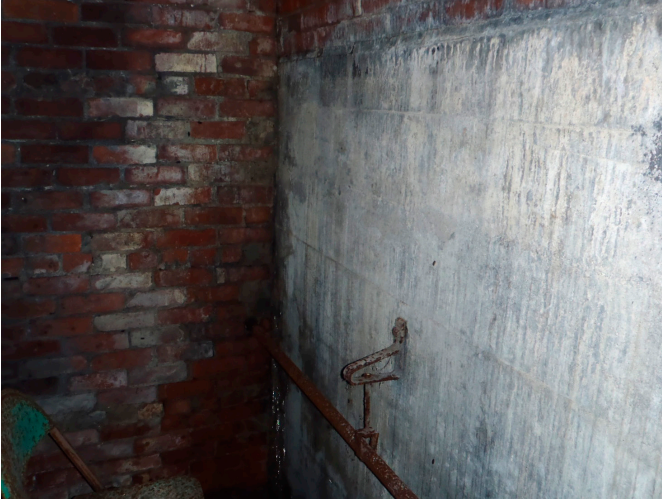
*Photo 1: Typical lower section of concrete foundation wall construction.*

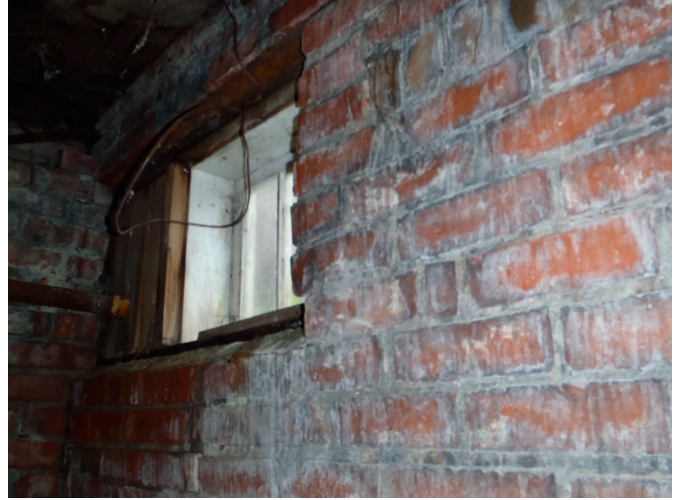
Some mortar deterioration and water damage was noted in the below grade masonry foundation

*Photo 2: Typical upper section of masonry foundation wall construction.*

- **Repair deteriorating and water damaged masonry foundation walls.**
- **Recommend introducing an exterior foundation drainage system, stone drip edge, and re-grading building perimeter to shed water away from foundation.**

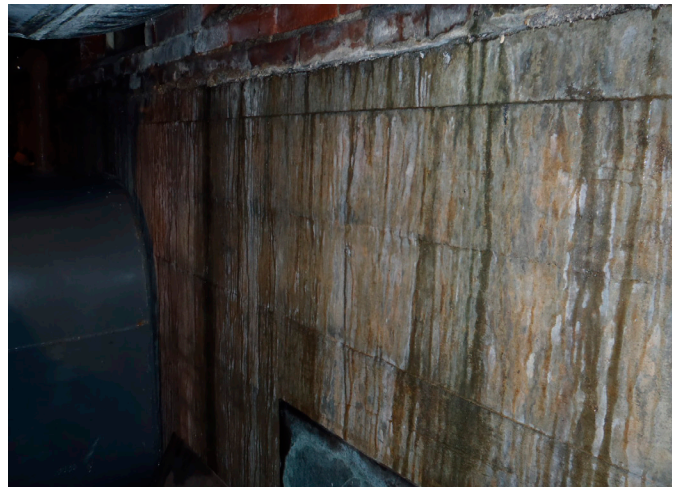
Based on limited observations from within the basement, the foundations appear in good condition for the age of the building and were likely constructed on good bearing material since signs of settlement and cracking are not evident. There were areas of floor slab with up to a half inch of standing water which was actively leaking through the below grade masonry wall construction. On the exterior, water shedding off the pitched roofs has scoured grade and ponds up against the building. (See Photo 3.)

*Photo 3: Water infiltrating the foundation wall through the upper masonry section.*

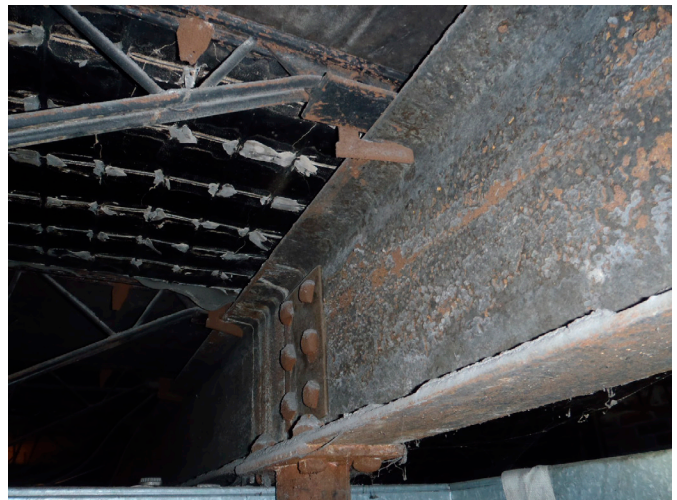
*Photo 4: Typical open web steel bar joist framing to interior girder connected with steel wedge clip.*

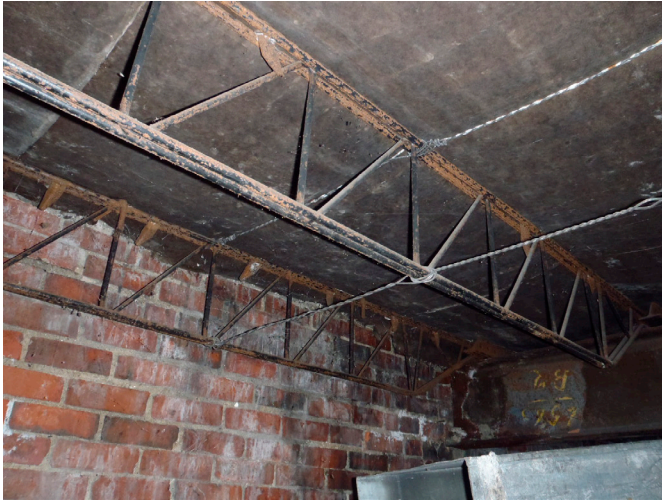
*Photo 5: Typical floor construction with concrete slab on steel bar joist framing with twisted wire bridging.*

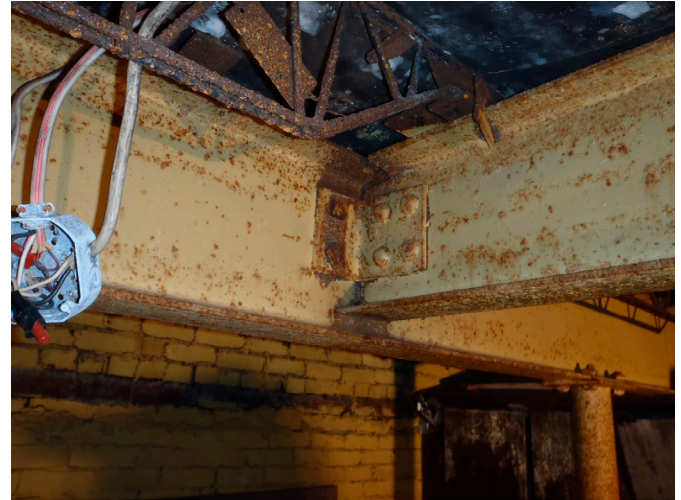
*Photo 6: Typical shop riveted and field bolted girder to girder connection*

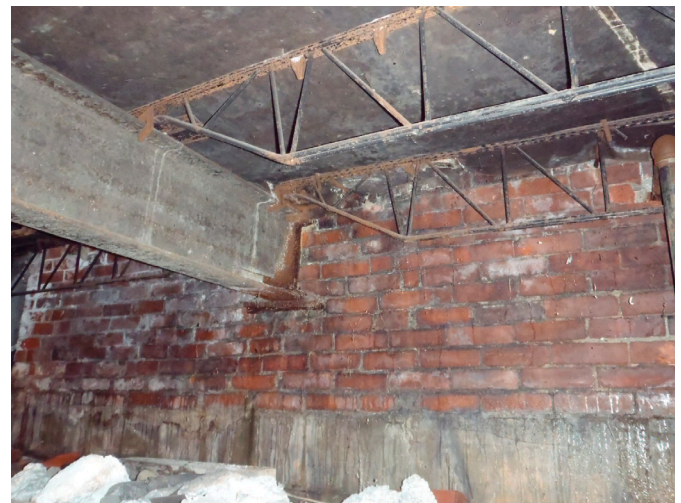
*Photo 7: Typical steel girder bearing in exterior masonry wall. Note rust on girder end where bearing in masonry and water infiltrating foundation wall.*

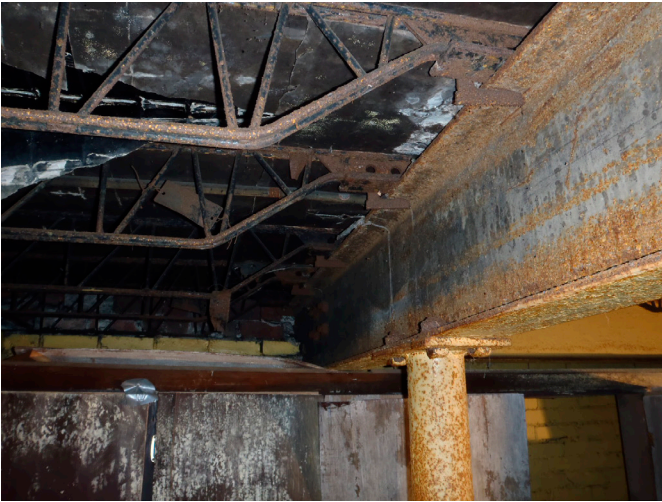
*Photo 8: Typical single story column to girder bearing plate connection.*

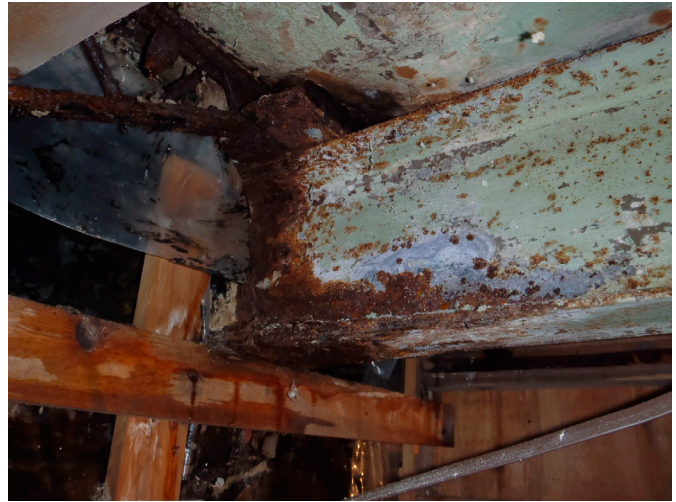
The dormitory floors are generally in fair to poor condition with isolated areas that show advanced deterioration mainly due to water infiltrating the building at the foundation and from the roof. The steel framing has signs of heavy rust and some section loss and the concrete slabs show water damage and likely has advanced deterioration due extended periods of wetness with freeze-thaw cycles. (See Photo 10 and 11)

*Photo 10: Steel joist and girder floor framing with heavy rust scale. Girder end framing to exterior masonry foundation wall construction.*

**\* Remedial work to repair the damaged areas including reinforcing heavily rusted sections of steel framing members and replacing small areas of slab are recommended as part of a future renovation.**

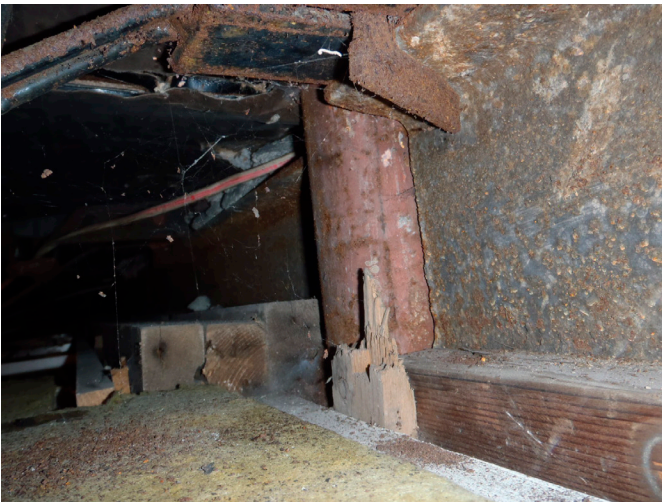
*Photo 9: Typical multi-story column to girder connection made with stiffened seat angles..*

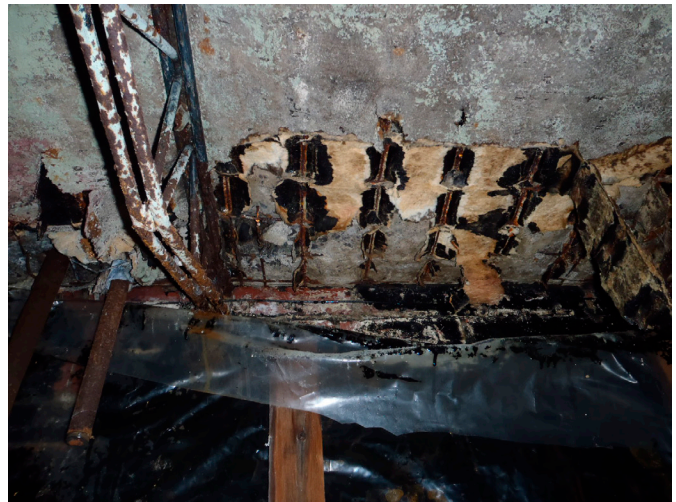
*Photo 11: Water damaged section of slab construction sagging and exposing rusted wire mesh reinforcement.*

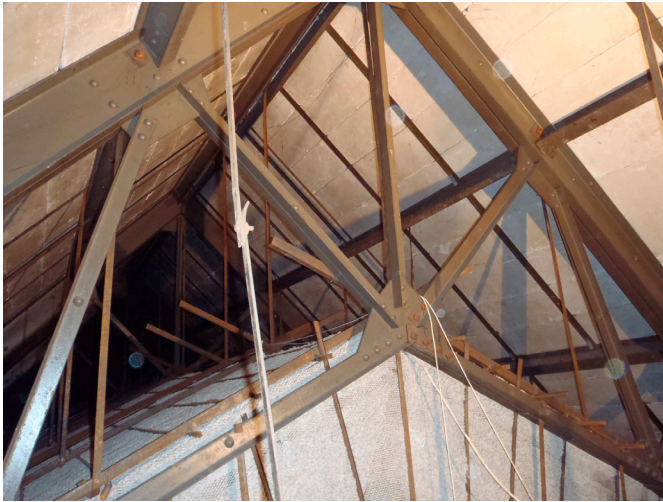
*Photo 12: Typical Chapel roof steel scissor truss with purlins, sub-purlins and gypsum tile roof deck.*

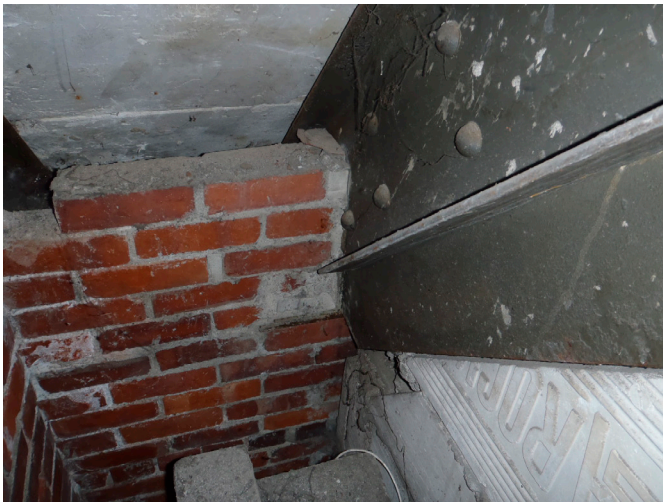
*Photo 13: Typical scissor truss double angle seat bearing at top of exterior masonry wall on steel bearing plate.*

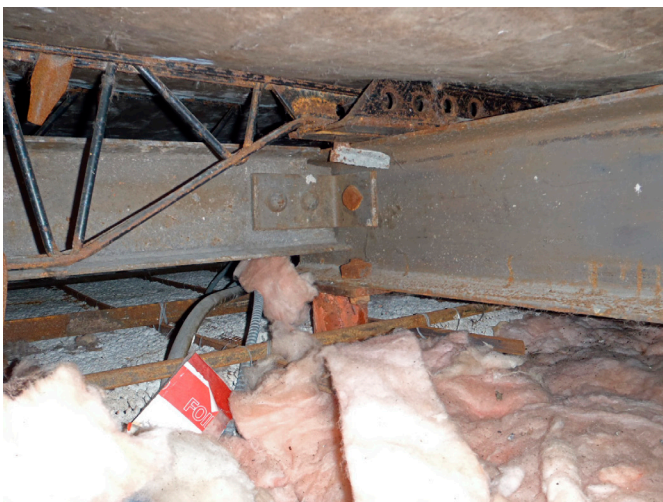
*Photo 14: Typical flat roof framing with concrete slab roof.*

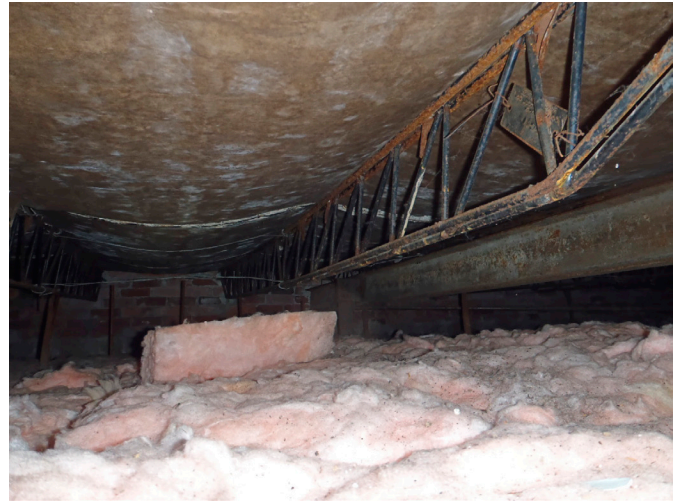
*Photo 15: Typical roof joist span to exterior masonry wall. Note sag in joist and concrete slab possibly caused by ponding water on roof.*

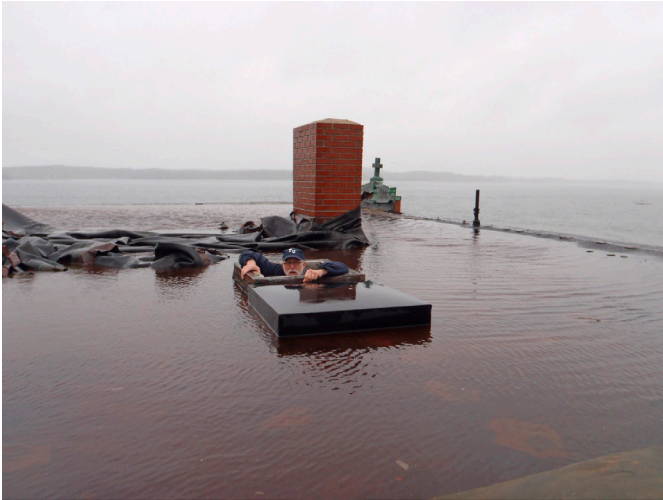
The flat roof combined with the poor drainage system makes the roof susceptible to increased loads caused by accumulation and ponding of rain or snowmelt-water that could accumulate to a depth that may overstress the roof structure. *(See Photo 16 and 17)* This roof is not insulated and the roofing is in very poor condition and in need of complete replacement with several areas actively leaking water inside the building. The internal roof drains are poorly functioning as upwards of 6 inches of standing water was noted on the roof.

*Photo 16 Significant depth of water ponding on the flat roof.*

- Replace roof drains and install a secondary roof drainage system such as scuppers through the parapet or internal overflow drains to prevent accumulation and ponding of rain or snowmelt-water.
- Remove the existing tar roofing system to reduce dead load. Replace existing roofing with a rigid insulation and rubber roofing system.
- Engineer and perform isolated roof reinforcements to increase snow load capacity at drift zones in accordance with Modern Code (as part of future re-roofing project).

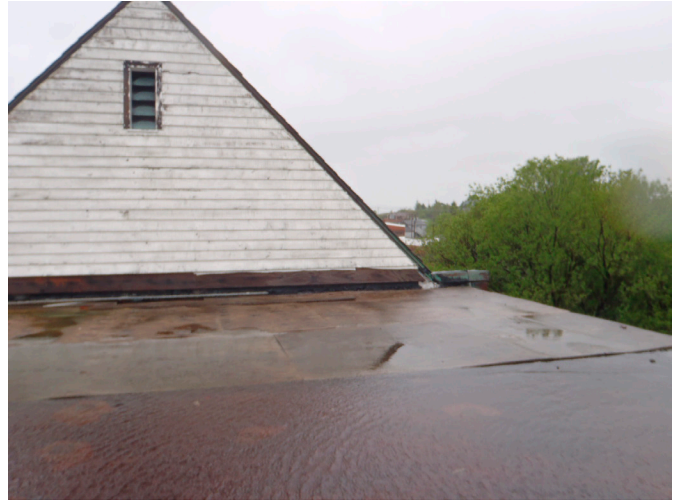
by drifting snow in the shadow of the taller roof. At this localized snow drift zone, the increased snow load could exceed the available capacity. As part of future re-roofing work, recommend engineering and performing isolated roof reinforcements to increase snow load capacity at this drift zone. This would be a voluntary improvement and not required by Code as building is essentially “grandfathered” provided the Occupancy does not change and the building structure is not substantially altered. (See Photo 18 and 19)

*Photo 18: Higher pitched roof creates snow drift zone on flat roof.*

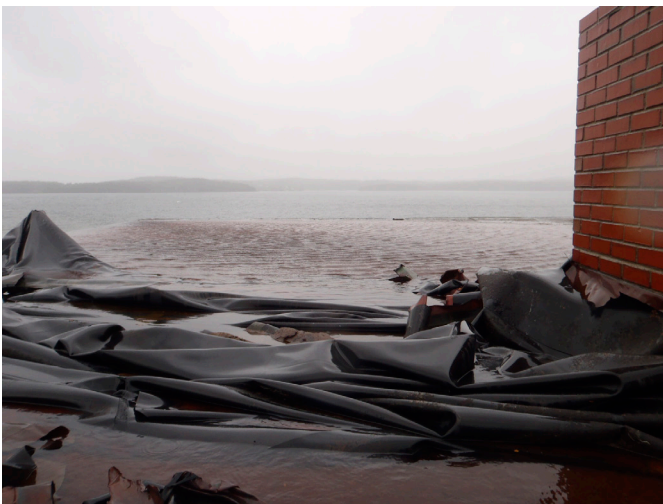
*Photo 17: Failed membrane roofing. Water ponding on original asphalt roofing and leaking into building.*

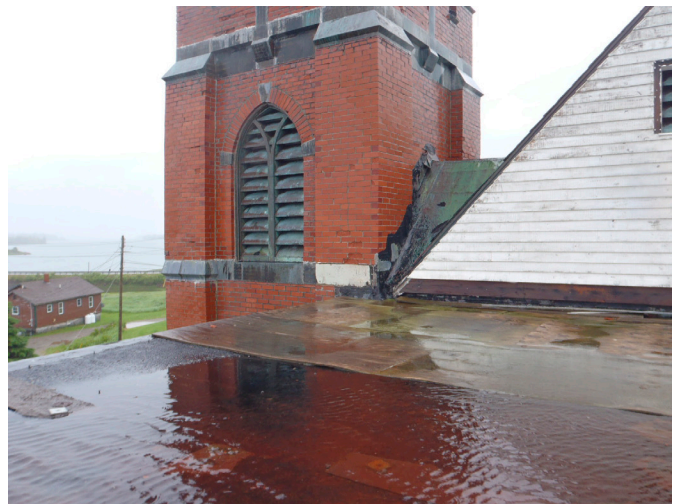
*Photo 19: Snow drift zone.*

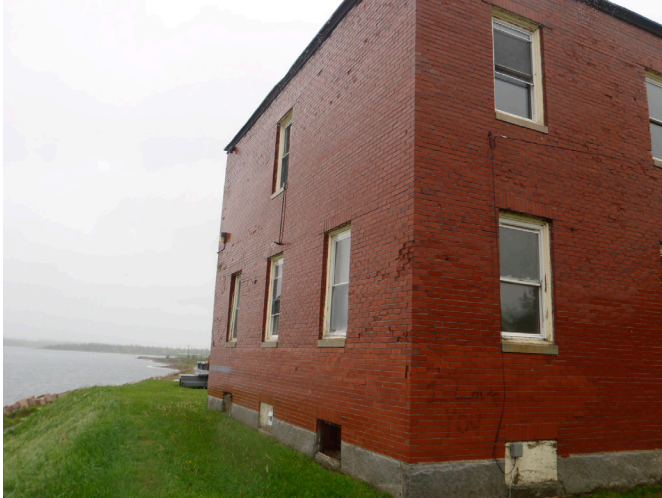
The exterior damage does not appear structural in nature as there are no signs of foundation movement (settlement or heaving), or signs of overstress at the building interior. Damage observed includes open vertical cracks, brick surface spalling, scoured mortar joints and wall base bulging which are likely caused by failing exterior envelope and water infiltration from poor roof edge conditions. Without a functional exterior envelope the exterior brick wythes are subject to

*Photo 20: East exterior masonry wall with cracked and spalling bricks.*

- Recommend performing extensive exterior brick wythe repairs and repointing within the next 3 years to minimize infiltration and damage to inner wythes.

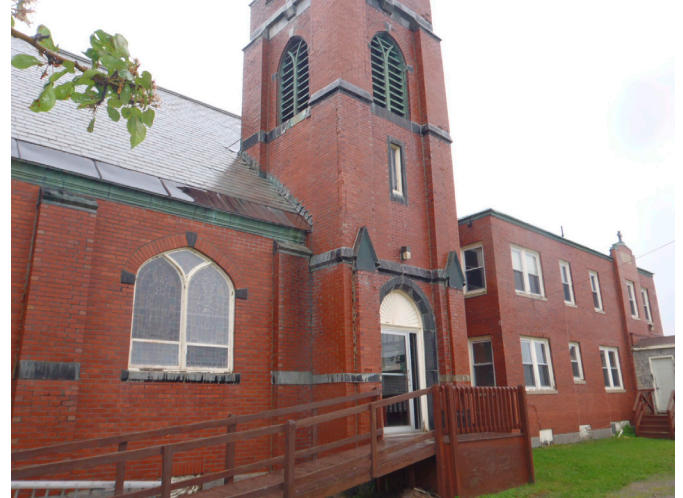
*Photo 22: Bell tower with open vertical cracks at each of the corners.*

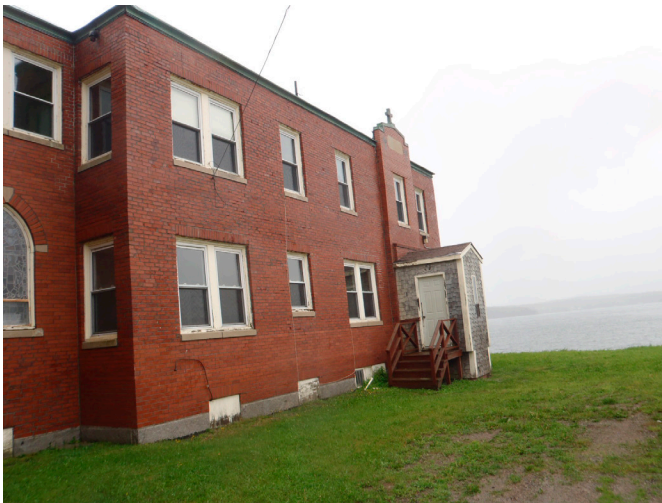
*Photo 21: South exterior wall of dormitory. Lower section of wall outer wythe appears to have been replaced and is bulging out at the base.*

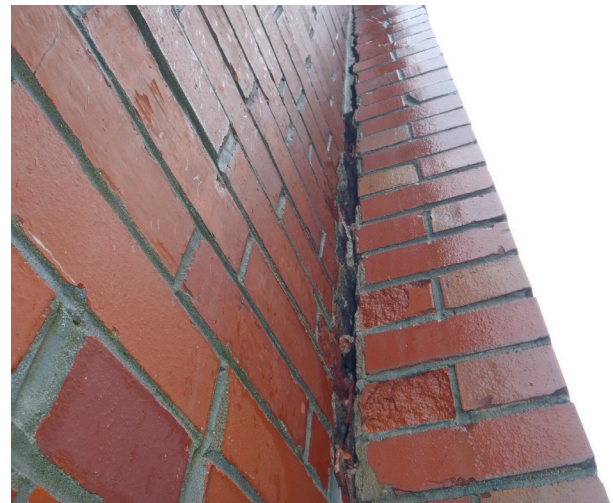
*Photo 23: Large open vertical crack at the connection of the pilaster to the exterior wall. Cracks were noted at most of the pilasters on the north and south façade of the Chapel.*

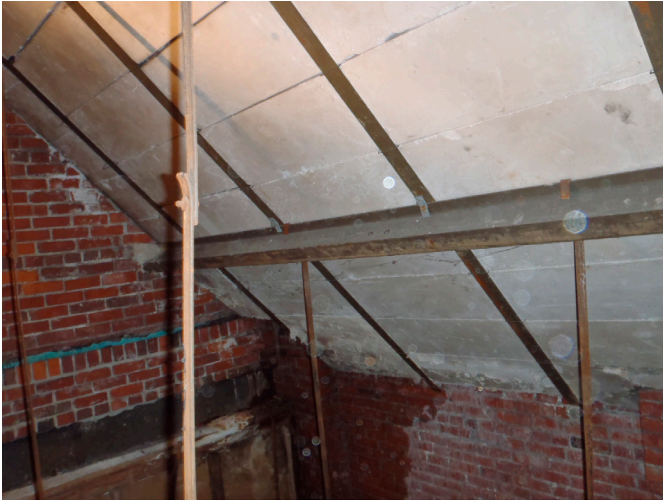
The interior wythes of the exterior brickwork appears to be in good condition with minimal cracks observed and generally intact mortar joints. Isolated water infiltration to the interior wythes was noted where the bell tower connects to the Chapel roof, the east wall of the Dormitory, and throughout the bell tower interior. *(Photo 25) (Photo 26)*

*Photo 25: Active water infiltration to the interior brick wythes at the connection of the bell tower to the Chapel roof.*

- Improve roof edge conditions and drainage to minimize exposure of exterior brickwork to roof shed water.

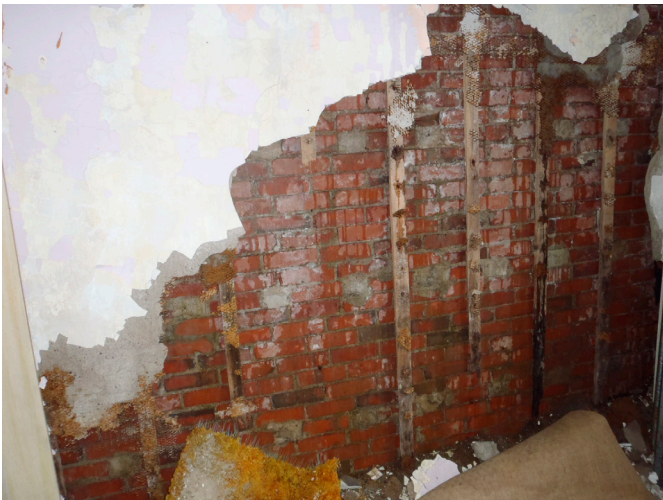
*Photo 26: Active water infiltration to the interior brick wythes at the east exterior wall of the dormitory.*

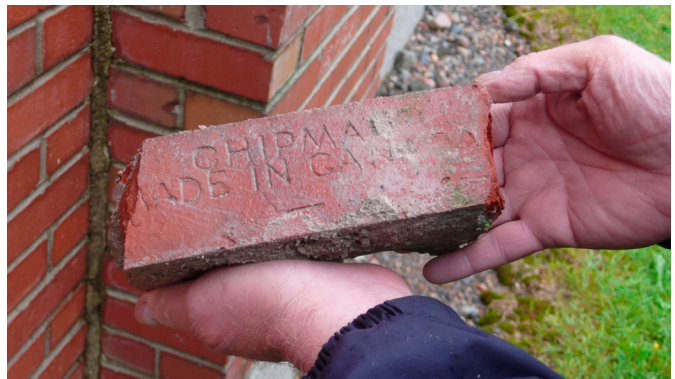
*One of the bricks removed from a badly deteriorated pilaster..*

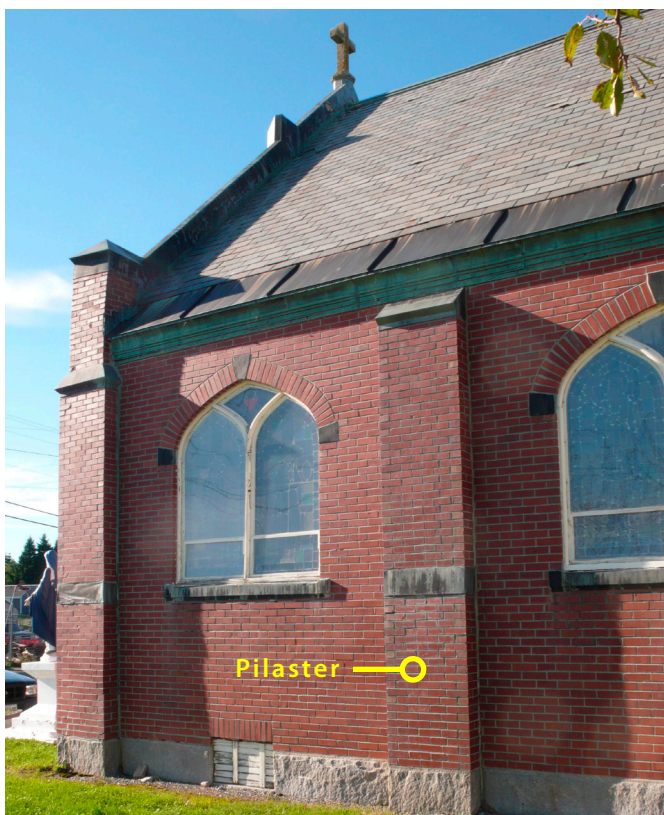
*Mason Ben Cawley inspecting a pilaster on the North facade. Note the 1" gap between the pilaster and wall. Mortar has deteriorated and water is penetrating deep into the wall cavity.*

Currently, all of the replacement pilasters are separating from the exterior walls to a greater or lesser degree. In the worst case (on the North side) there is a 1" between pilaster and wall. These gaps allow wind driven rain to penetrate deep into the exterior wall. Saturating the interior brick and mortar. This, along with the freeze/thaw cycle, hastens the deterioration of the wall assembly. I should be noted that conditions like this start the deterioration slowly but the damage increases exponentially as the cause goes untreated. A problem that might have been fixed easily (and inexpensively) ten years ago now requires complete (and costly) replacement. This applies to the building as a whole. At this point, all of the pilasters are severely deteriorated, some to the point where the interior mortar has liquefied to a wet mud and the only thing holding the bricks together is gravity and capillary action.

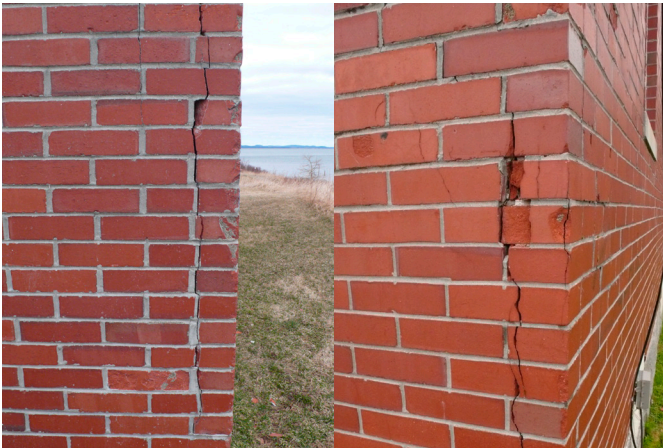
*Examples of vertical cracking. On the left, an inferior repair creates a contiguous mortar joint, creating a line of weakness, which makes the cracking inevitable.*

All the exterior faces of the building show large, prominent areas of vertical cracking, both along mortar joints and through the bricks. There are also several instances of cracking in the veneer stone base.

It is important to note that all of the observed cracking appears to be only in the exterior wythe of brick, not on the interior 2-3 wythes. This would indicate that the damage is caused by the action of improper re-pointing creating stresses in the wall such as expansion, contraction and moisture migration

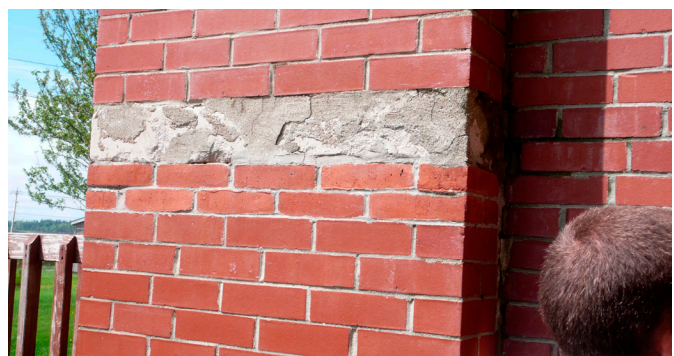
All of the trim, ornamentation, blocks, sills, quoins, column caps, parapets and various other details are shop fabricated, cold-formed, soldered, 20-gauge, lead coated copper sheet flashing. In the case of the trim bands, window sills and tower ornamentation, the copper covers precast unreinforced concrete blocks which are integrated with the brick masonry and bonded with mortar. The copper flashing is applied in the field during

*Here, the lead coated copper flashing has been removed, exposing the precast concrete block.*

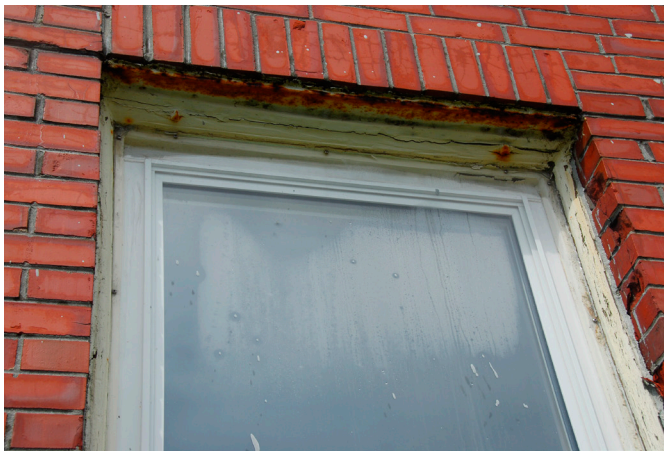
*Corroded steel lintel over one of the convent windows.*

unit which supports the window header course in these locations, the lintels are severely corroded due to the leaking of the convent roof causing the brick exterior walls to be in a state of constant water saturation. The lintels should be checked for structural integrity and replaced as necessary.

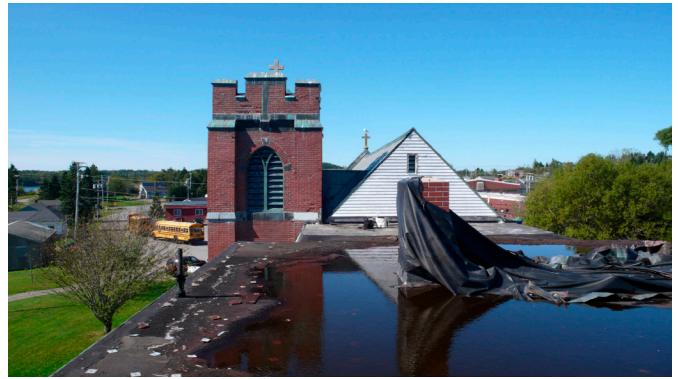
*Photo of the roof of the Convent showing the severe ponding and former membrane roofing system, now uselessly piled up. This roof is completely unprotected and porous, distributing water into the building interior on a year round basis. This is the cause of nearly all the deterioration of the Convent section.*

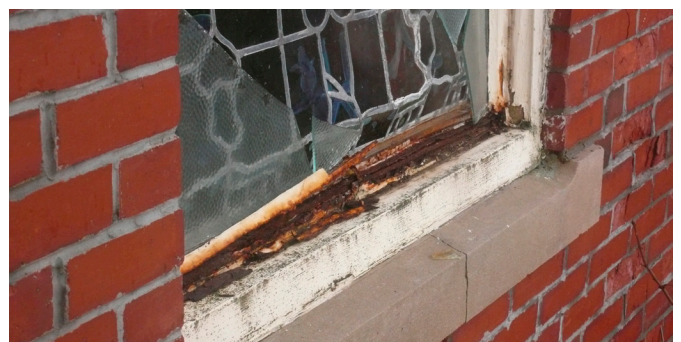
*Water leaking from the roof of the convent causing rusting of the steel frame of a priceless stained glass window. Without immediate attention this window will be lost in a few years.*

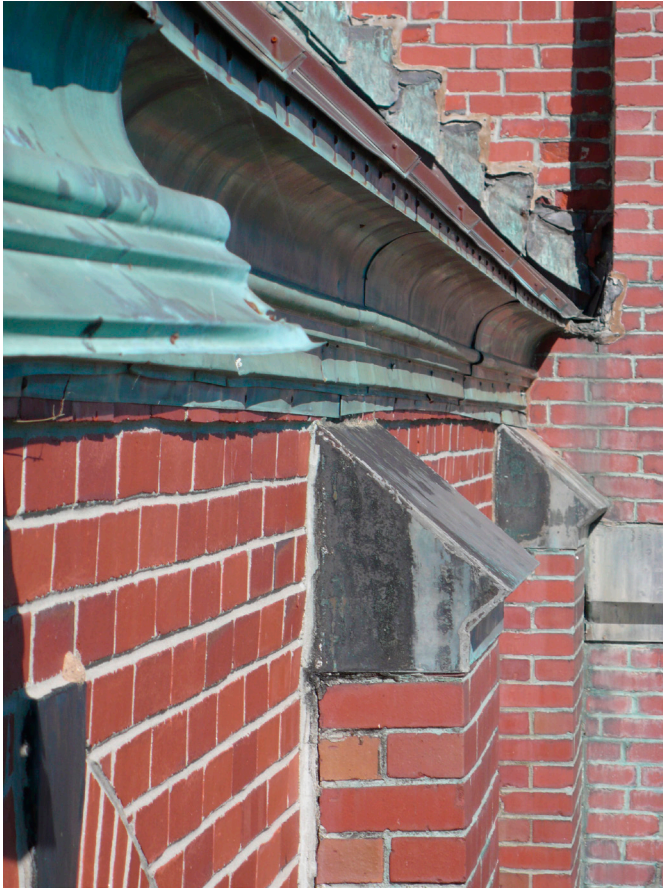
*Looking down along the line of the eave trim of the Chapel showing the lead coated copper trim and pilaster caps.*

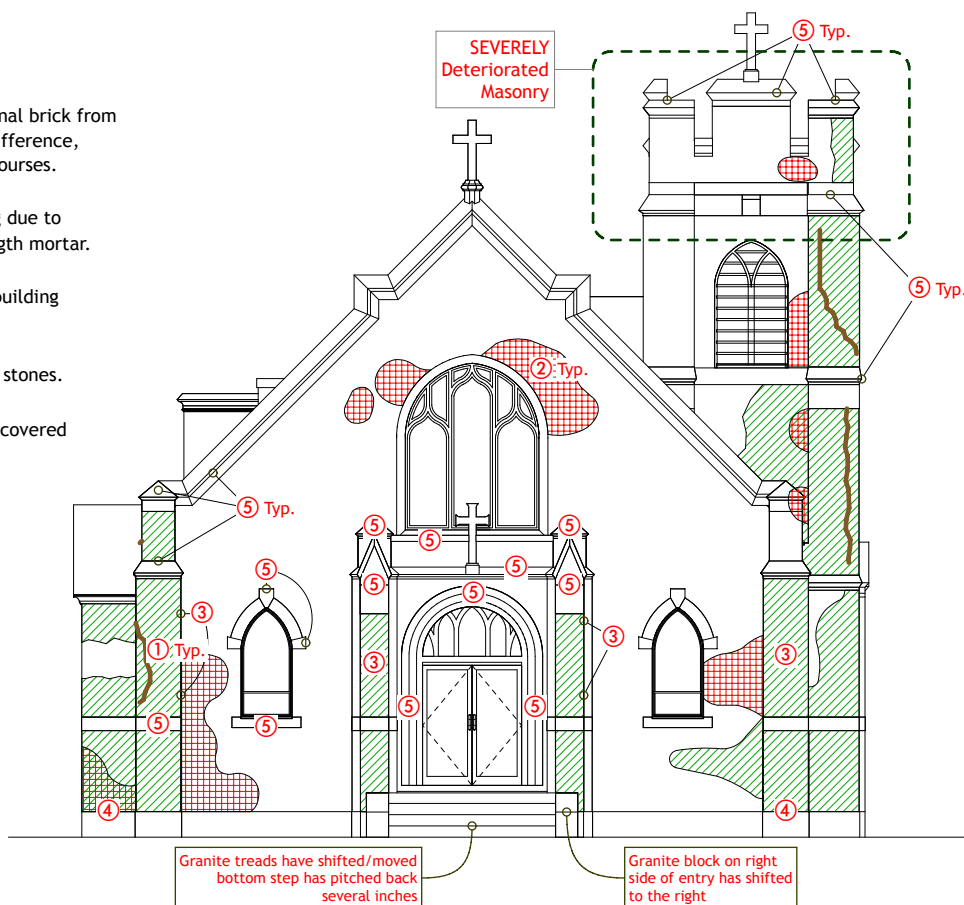
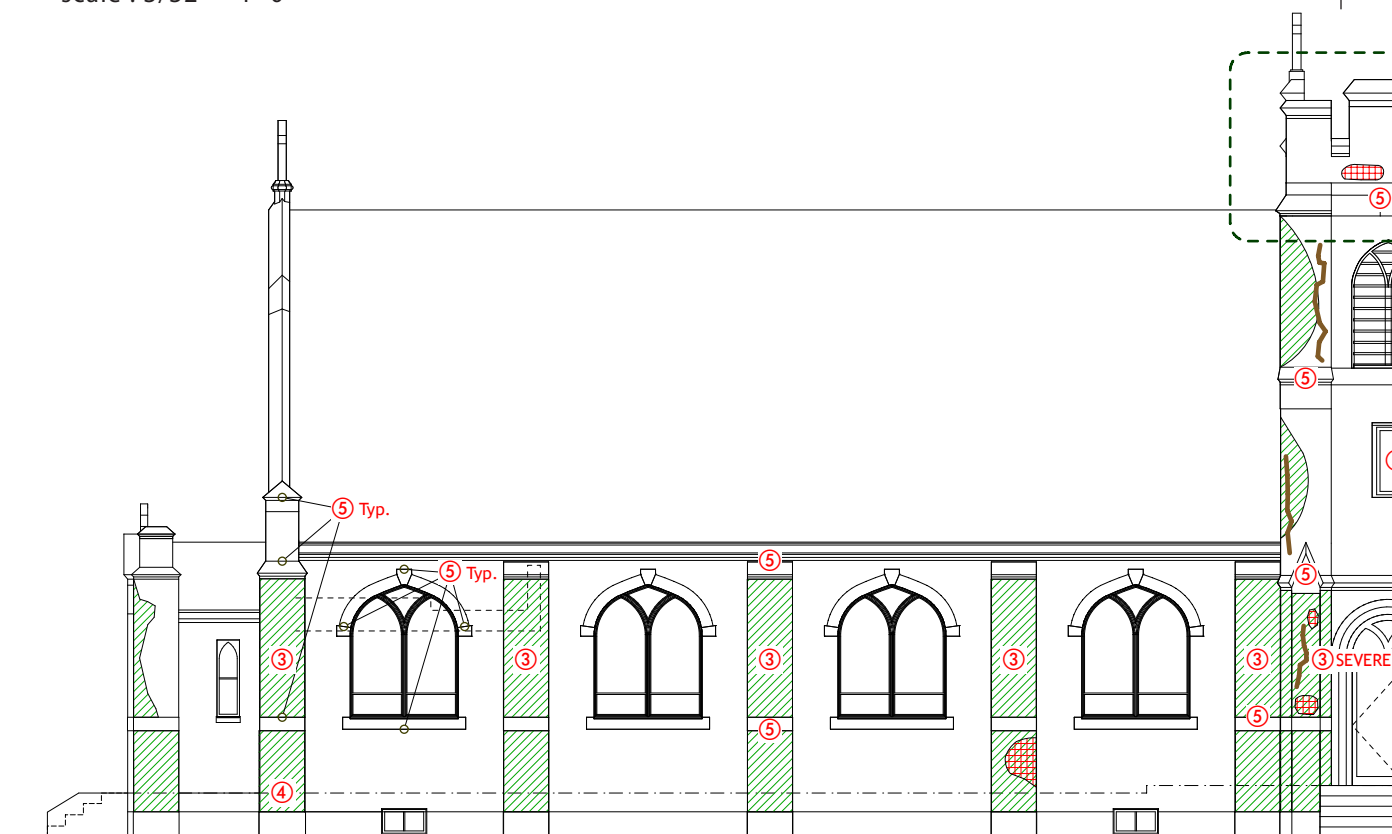
## WEST Elevation

- ① Areas of what appear to be non-original brick from previous repairs indicated by color difference, size difference, and lack of header courses.
- ② Areas of extensive brick face spalling due to incorrect re-pointing with high-strength mortar.
- ③ Separation of pilaster/column from building at vertical joint.
- ④ Cracking in brick near granite corner stones.
- ⑤ Deteriorated precast sills and blocks covered in lead-coated copper.
- ⑥ Corroded Steel Lintels.
- ⑦ Major vertical cracks in brick.
